**MEMORANDUM REPORT VRTC-DCD-6102
EA05-022**

Investigation of Front Seatbelt Buckle Malfunction in 2002 Jeep Liberty Vehicles

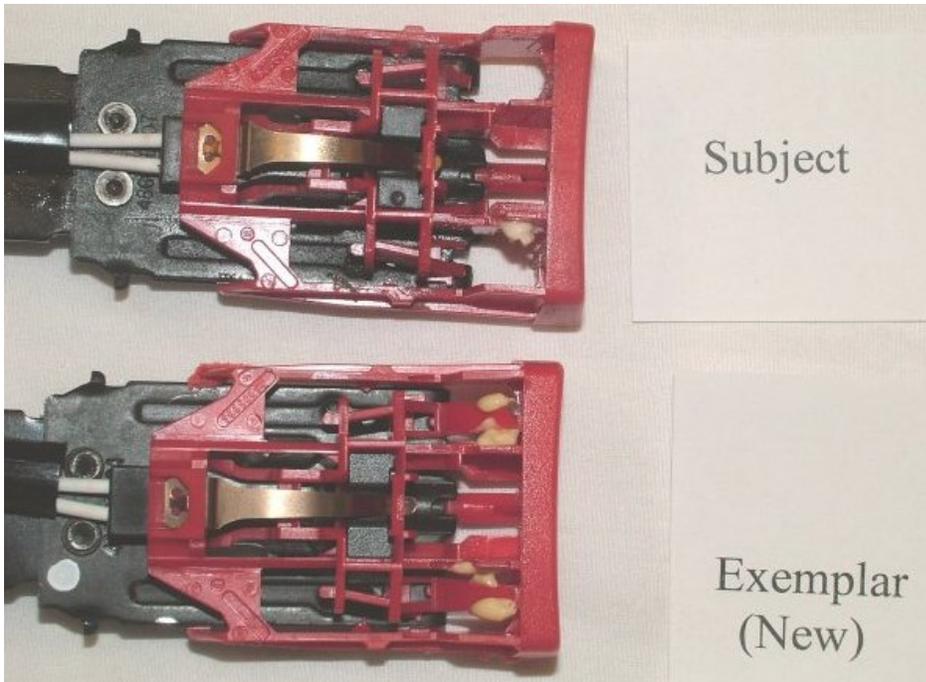
The exemplar buckle was opened first and set aside for later comparison to the subject buckles. As each subject buckle was opened, it became apparent that each exhibited the same failure mode. Both leaf springs on all five subject buckles were found to have detached from the latch guide. The leaf springs were loose in some of the buckles, missing in some of the buckles, and wedged under a sliding piece in one of the buckles.

Figure 1
Side-by-Side Comparison of Subject and Exemplar Buckles (Note Missing “Spring” Pieces Directly behind Button on Subject Buckle)

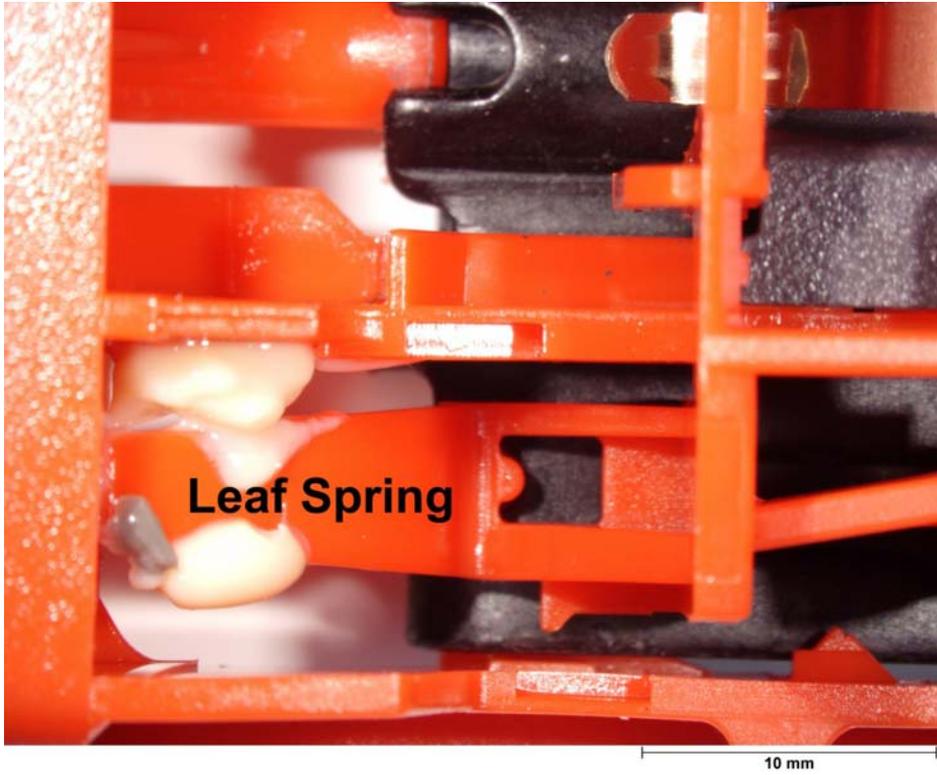
Figure 2
Exemplar Buckle
Leaf Spring as
Manufactured
(One of Two)

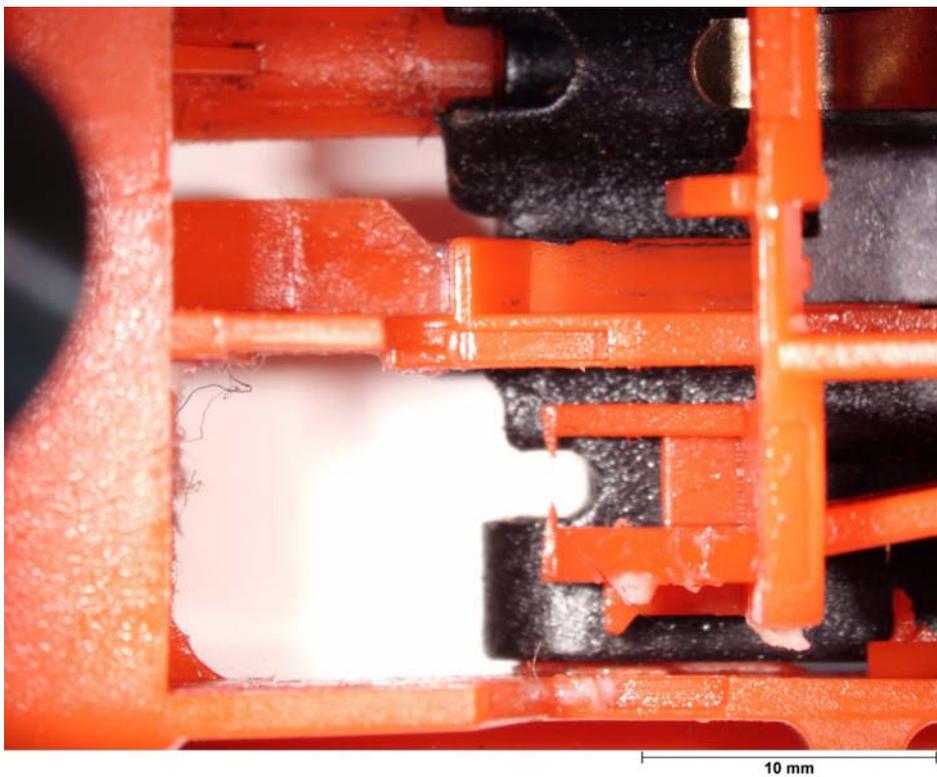
Figure 3
Area of Missing
“Spring” and
Fracture Surface on
Complaint Buckle
(Typical)

The attachment surface of the leaf springs to the latch guide is very small ($<.006 \text{ in}^2$ each). Both of the leaf springs had separated from the latch guide in all five of the subject buckles that were inspected. Random positioning of the loose leaf springs may cause random faulty operation of the buckle for a number of reasons, depending on the location of the loose leaf spring at any given time. Some of the problems discovered during these inspections include:

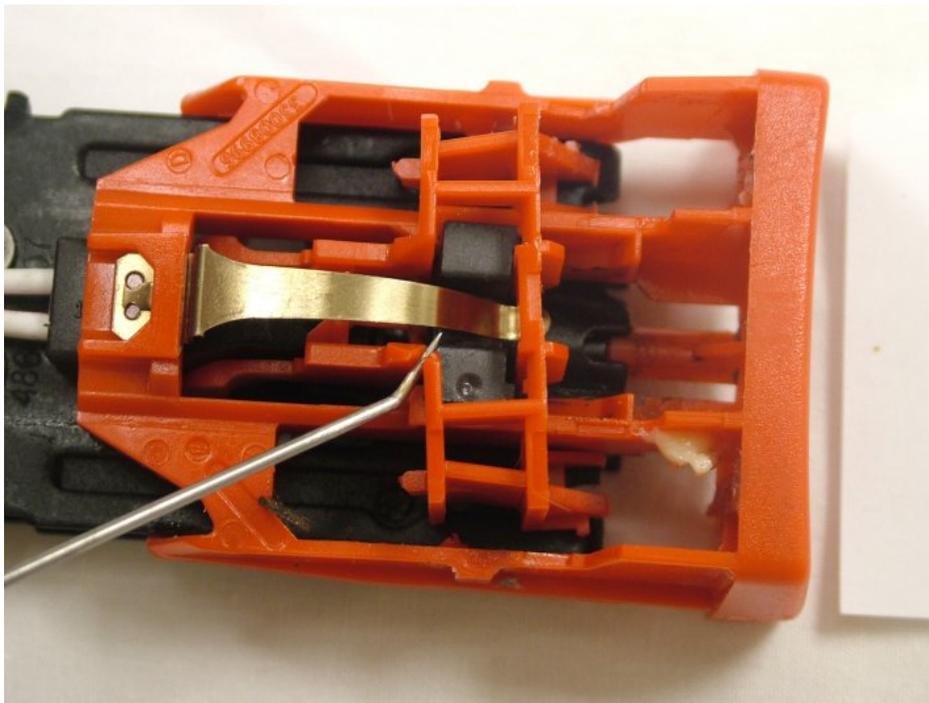
As received at VRTC, the release button was stuck in the depressed position. Lightly tapping the buckle with one finger caused the button to return to the normal (non-depressed) position. The buckle would usually not latch until greater-than-normal force was exerted on the latch plate. Once latched, the buckle appeared to hold properly. When the button was depressed in an effort to release the latch plate, the latch plate was ejected but the button remained depressed. After opening the buckle housing, both leaf springs were found to be detached. One of the broken leaf springs fell out when the housing was opened. The other spring was not located. One side of the latch guide was found to be fractured. After the loose piece fell out, the function of the buckle returned to normal except that the latch guide was observed to move briefly upward as the latch plate was ejected. The button returned to the normal expected position after release of the latch plate. Figures 4 and 5 show the fractured latch guide. Figure 6 shows the loose leaf spring. Figure 7 shows the position of the release button as received.

Figure 4
Fractured
Latch Guide

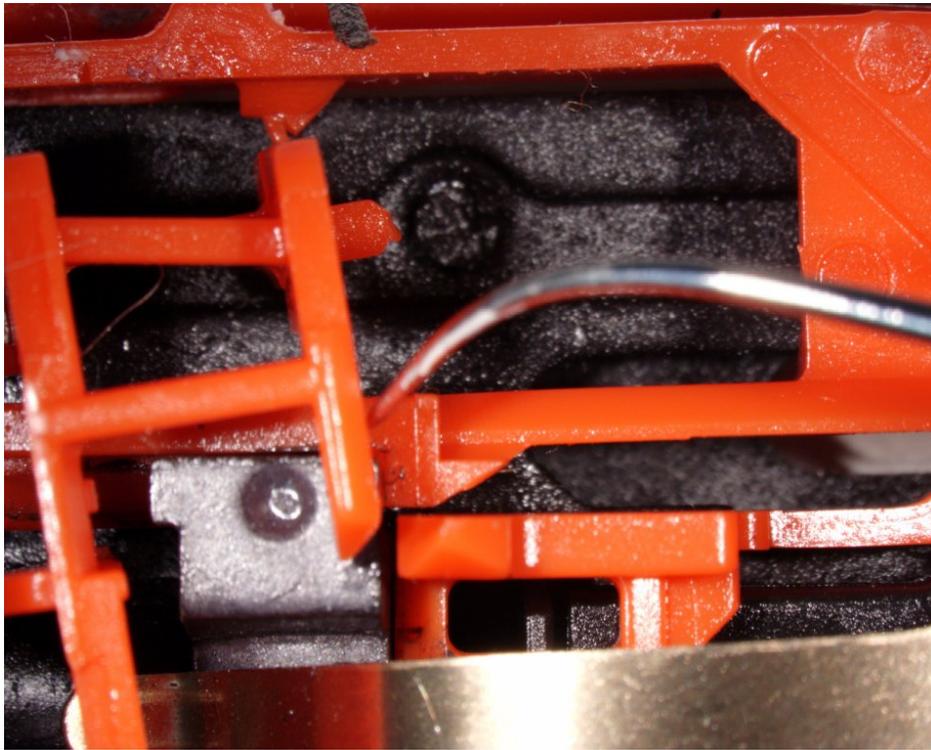
Figure 5
Close-Up of
Fractured Latch
Guide

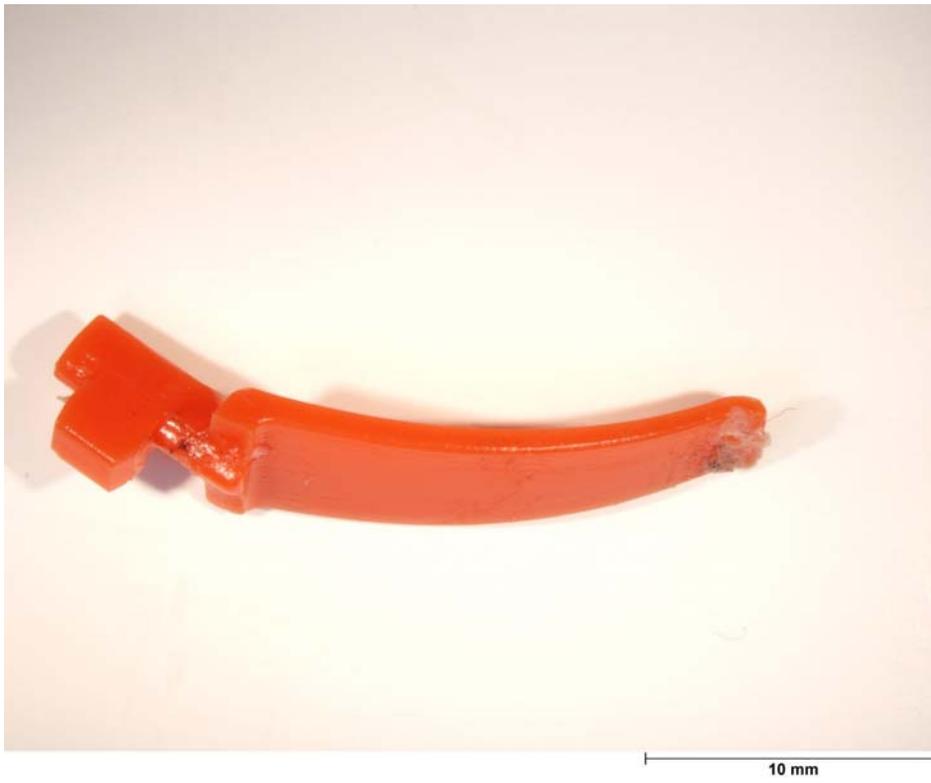
Figure 6
Loose
Leaf Spring

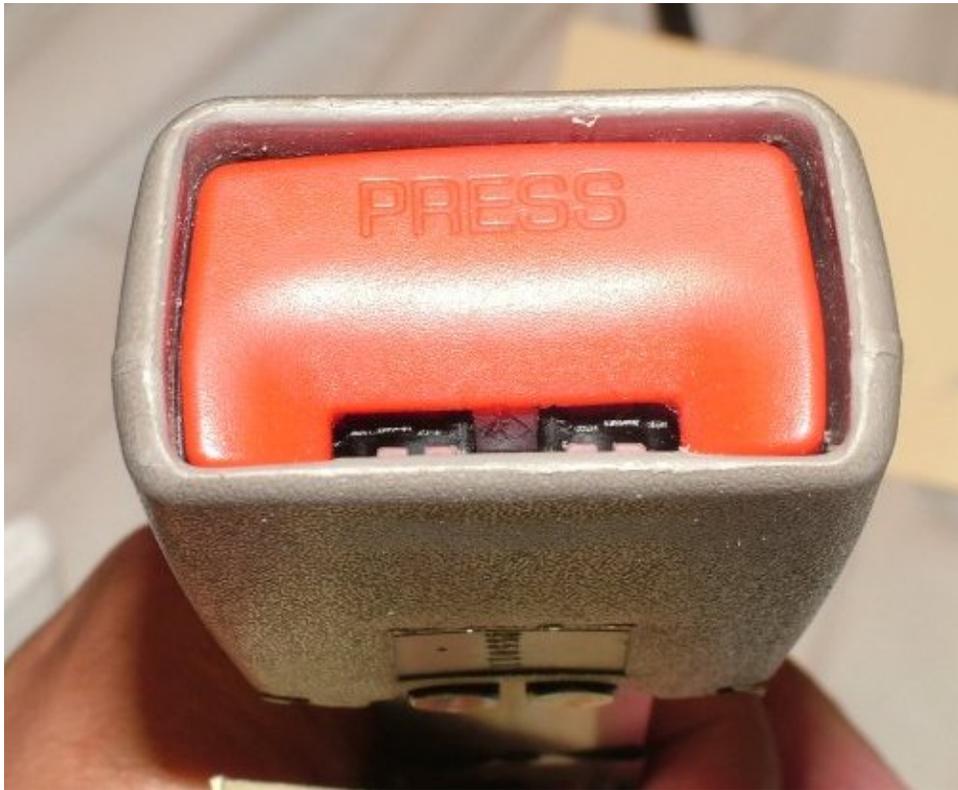
Figure 7
Release Button as Received

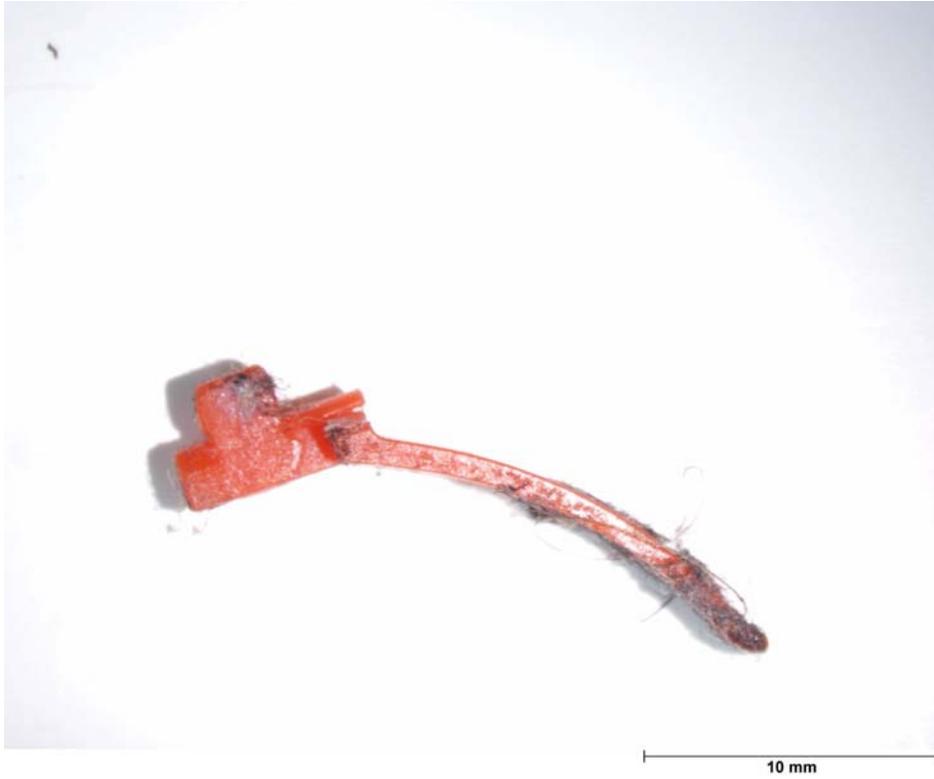
As received, the buckle appeared normal and would latch with ordinary force. Once latched, the buckle appeared to hold properly. When the button was depressed to release the latch plate, the latch plate was ejected and there was a slight delay before the button returned to the unlatched position. After opening the buckle housing, fibrous foreign material was found on the internal parts of the buckle, including the loose leaf springs. Both leaf springs were found to be detached. One of the broken leaf springs fell out when the housing was opened. After the loose piece fell out, the button remained in the depressed position after the latch plate was ejected. Slight pressure on the bottom of the button caused it to return to the normal position. The latch guide was observed to move briefly upward as the latch plate was ejected.

Figure 8
Loose
Leaf Spring

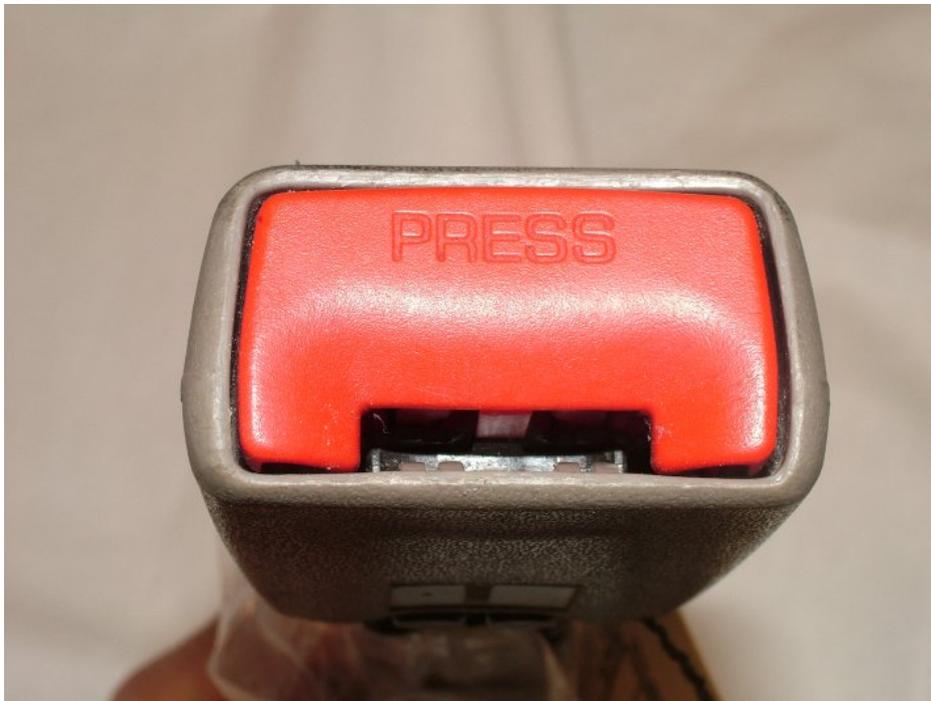
Figure 9
Release Button as
Received

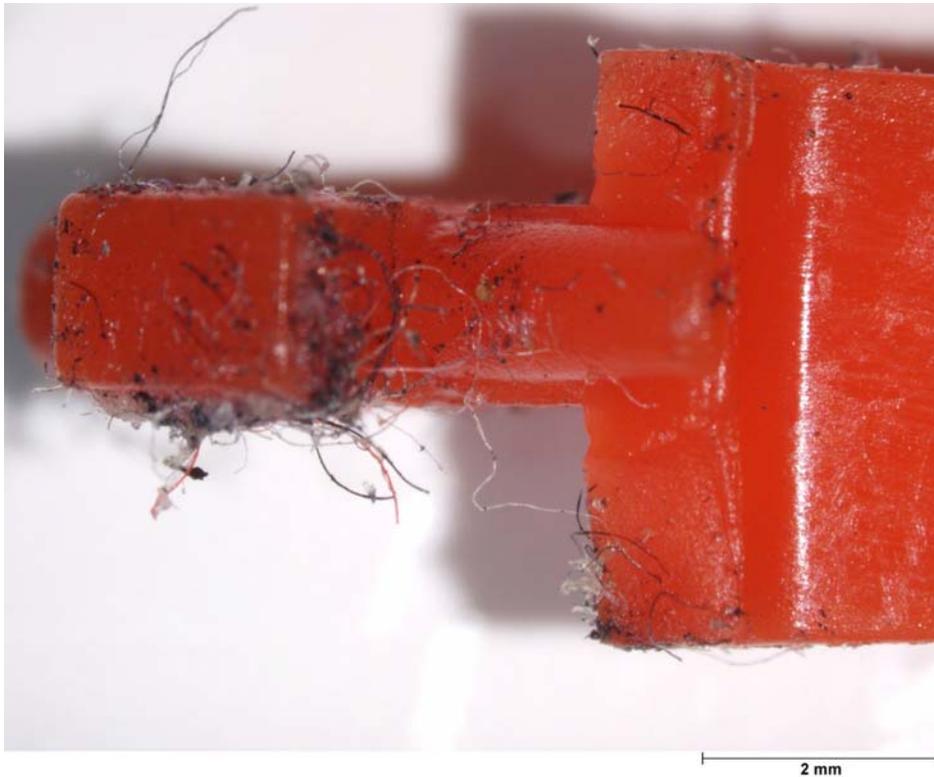
Figure 10
Foreign Material on
Broken Leaf Spring

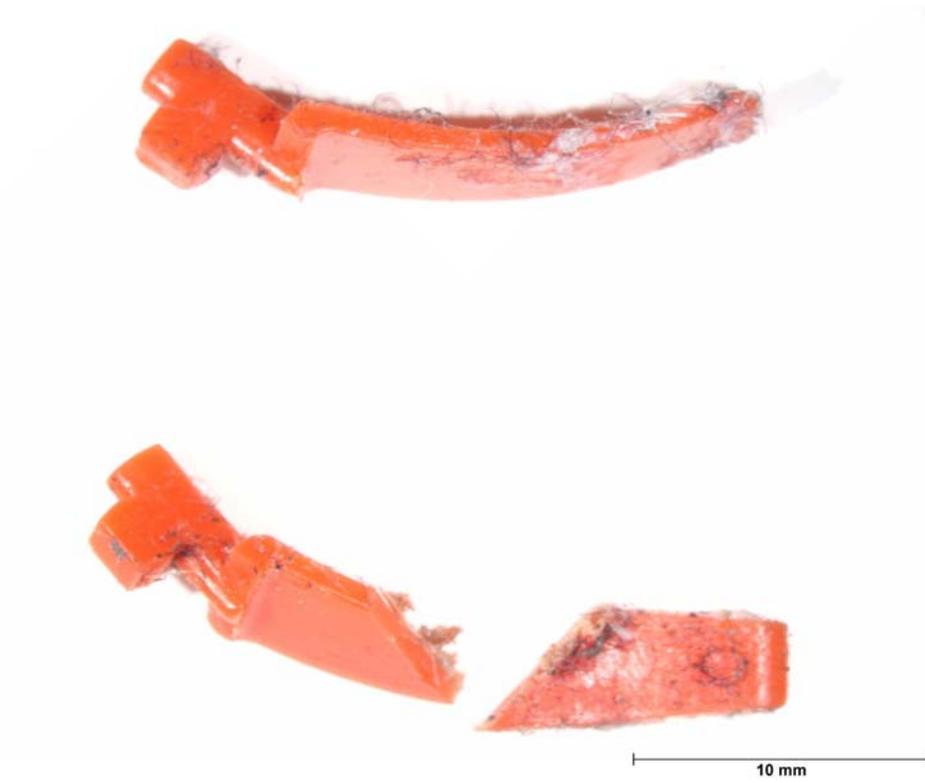
As received, the button was stuck in the depressed position and would not move. The latch plate could be inserted but the buckle would not engage the latch plate. After opening the buckle housing, both leaf springs fell out. One of the leaf springs was in two pieces and appeared to have been sheared. Some foreign material was found within the buckle. After the leaf springs fell out, the function of the buckle returned to normal except that the latch guide was observed to move briefly upward as the latch plate was ejected. The button returned to the normal expected position after release of the latch plate.

Figure 11
Two Loose Leaf Springs

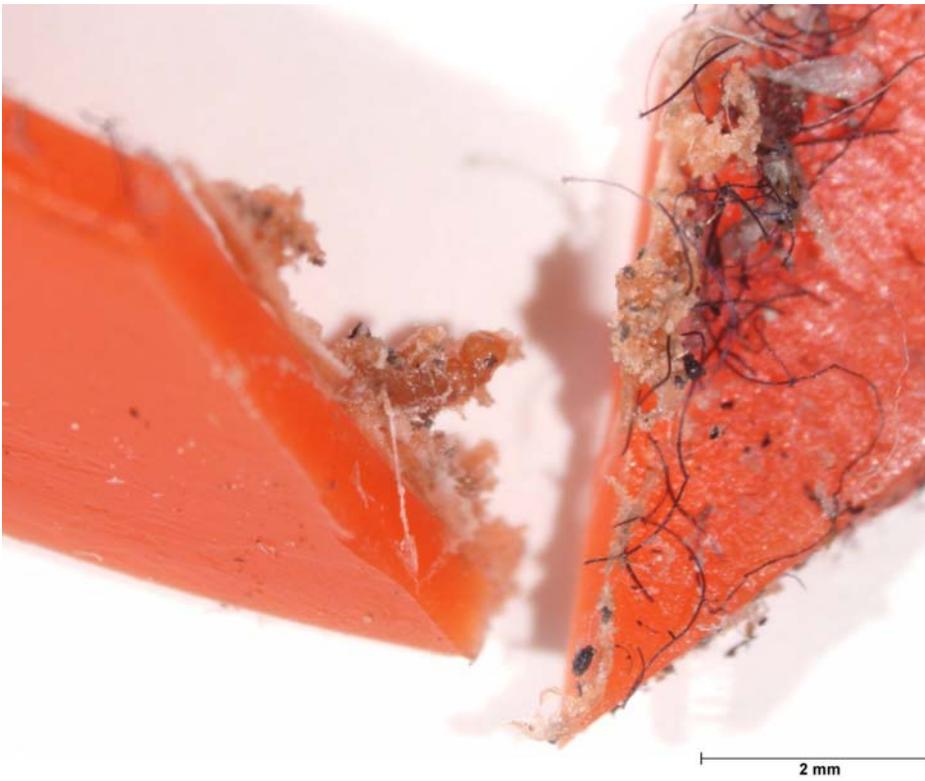
Figure 12
Shear Location on Leaf Spring

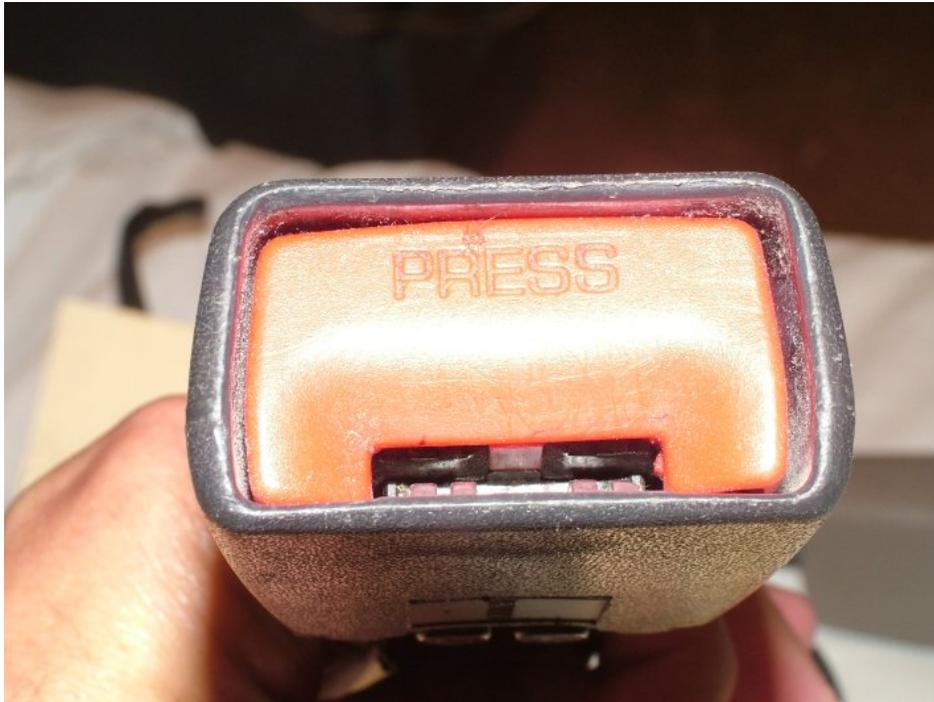
Figure 13
Release Button as
Received

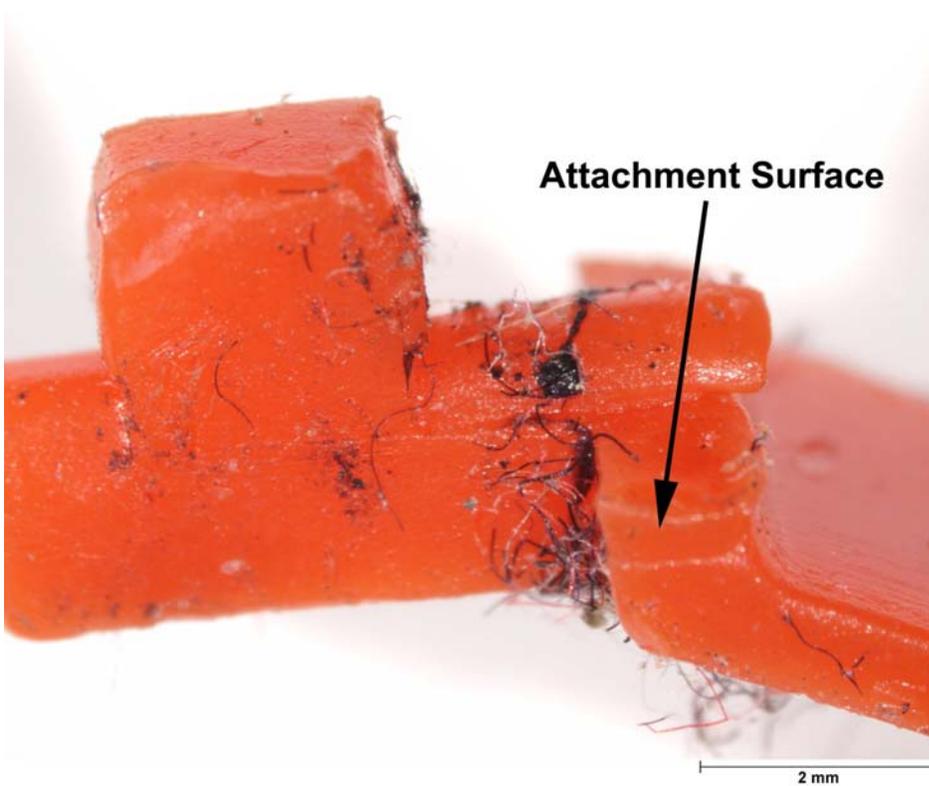
Figure 14
Leaf Spring
Attachment Surface
to Latch Guide

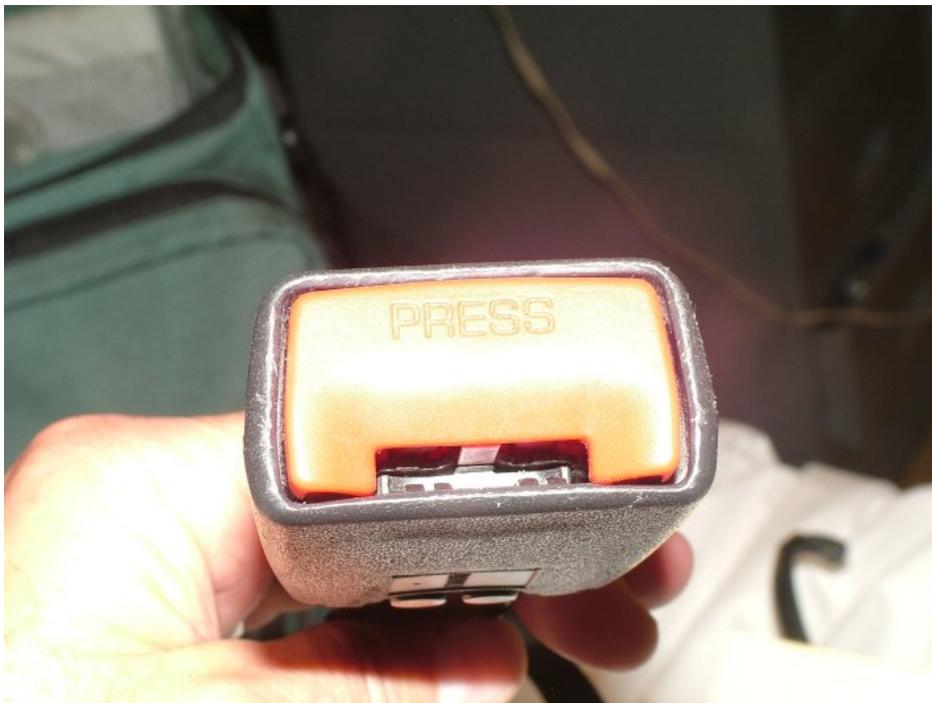
As received, the release button was in the depressed position. Lightly tapping the buckle caused the button to return to the normal (non-depressed) position. The buckle latched with ordinary force. Once latched, the buckle appeared to hold properly. When the button was depressed to release the latch plate, the latch plate was ejected but the button remained depressed. After opening the buckle housing, both leaf springs were found to be detached (neither was present) and the operation of the buckle remained the same as the as-received condition. The latch guide was observed to move briefly upward as the latch plate was ejected.

Figure 15
Release Button as
Received

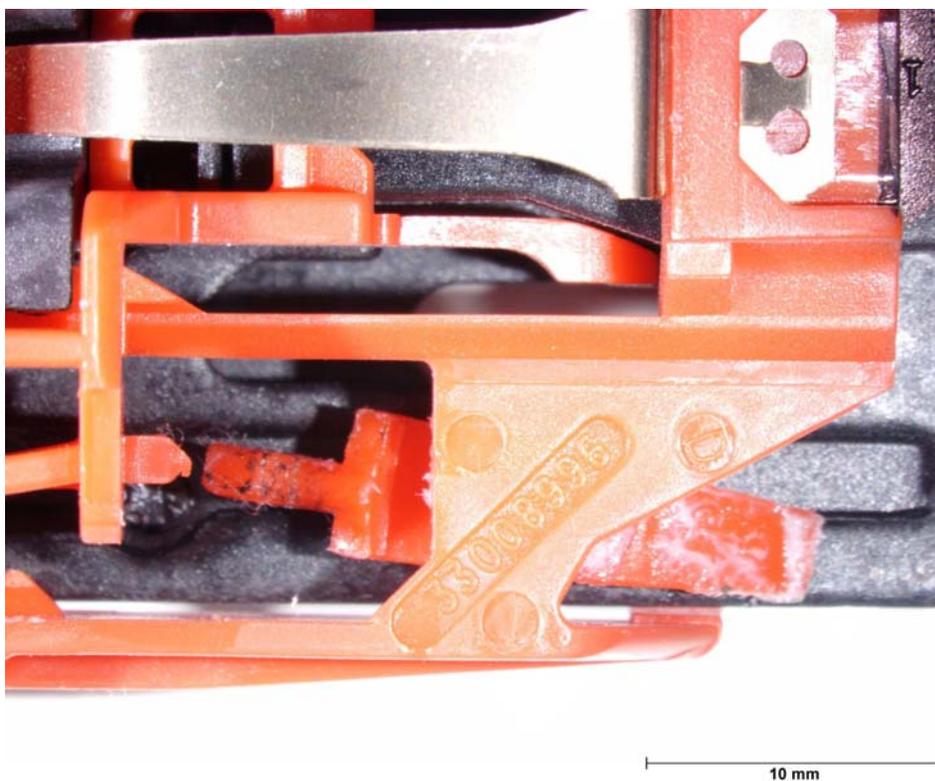
found to be detached and both were present. The right leaf spring was loose and fell out when the housing was opened. The left leaf spring was found wedged under the rear (lower) part of the sliding button. After the loose piece fell out, operation of the buckle remained the same as the as-received condition except that sometimes the button would return to the normal (non-depressed) condition and sometimes it would remain depressed. When the button remained depressed, slight pressure on the bottom of the button caused it to return to the normal position. The latch guide was observed to move briefly upward as the latch plate was ejected.

Figure 16
Loose Leaf Spring
Wedged Under
Latch Guide

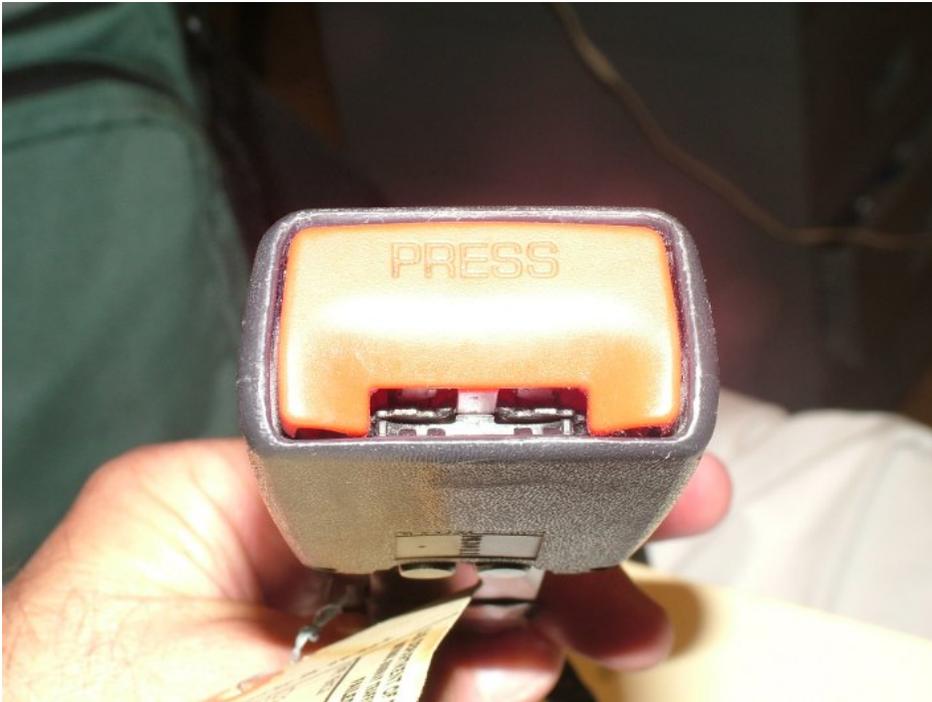
Figure 17
Release Button as
Received

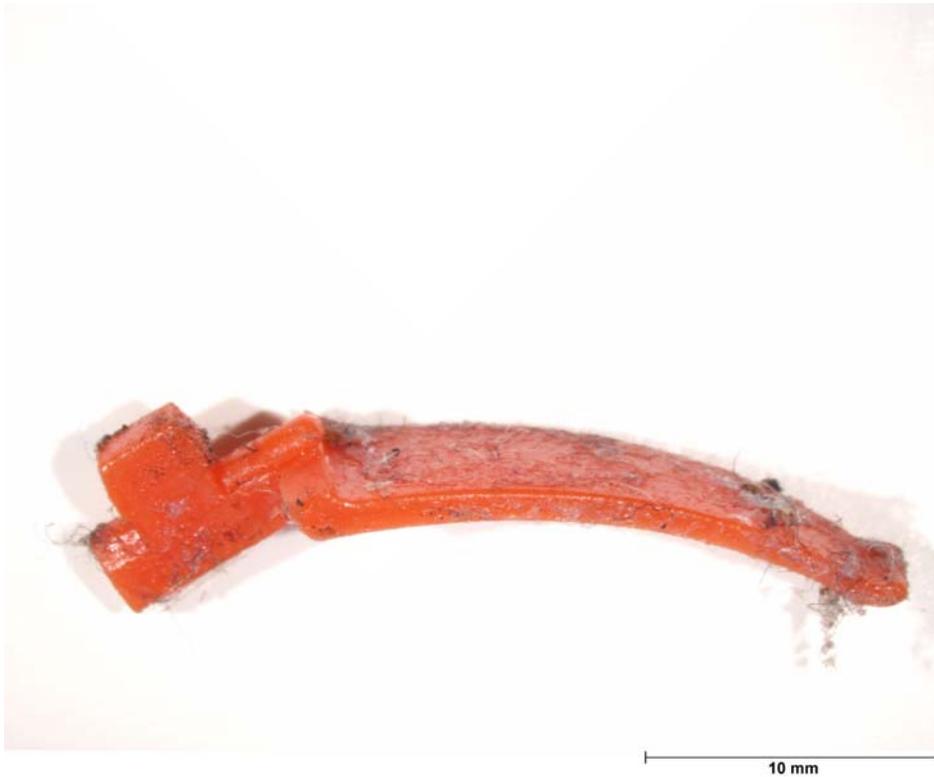
One of the broken leaf springs was found loose in the packing material that the buckles were shipped in from ODI to VRTC. The source buckle is unknown except that it could not have been buckles 3 or 5 because both of the leaf springs in both of these buckles were still present. Of the remaining three buckles, it is suspected that this loose leaf spring came from Buckle #2 because of the foreign material present on the loose spring. Figure 18 shows the leaf spring that was found loose in the shipping package.

Figure 18
Loose Leaf Spring
Found in Packing
Material
